JARAMA RIVER RESTORATION PROJECT (VALDETORRES): Case study

Jarama River: middle reach El Molar (Madrid)

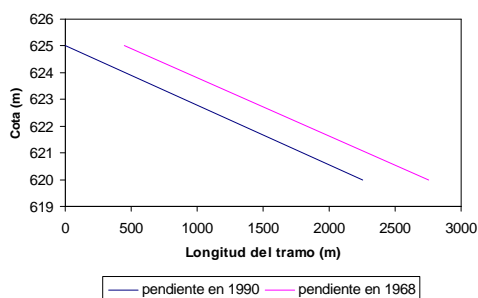
Longitudinal Profile

River Jarama base level lowered due to:

- Gravel extractions directly from river bed, and also from the riparian system
- Decrease of bed load and transported sediments

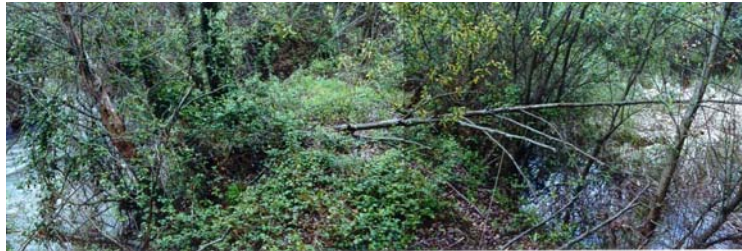
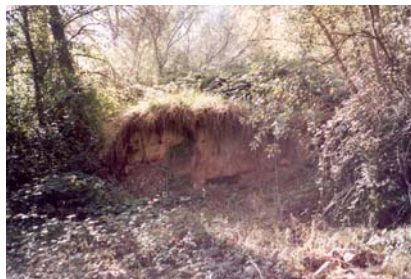
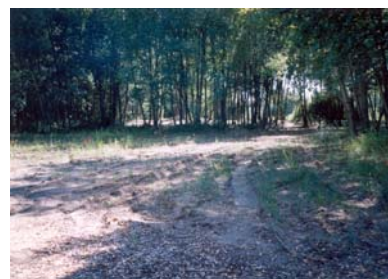
Old levees & dykes
