URBAN STREAM REHABILITATION IN MADRID (SPAIN)

M. González del Tánago

J. Azcárate

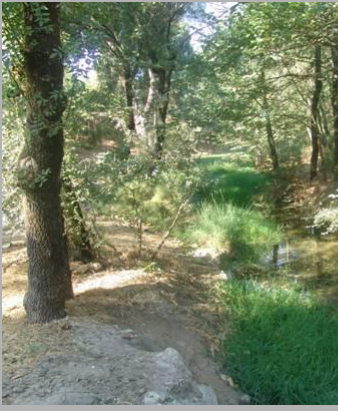
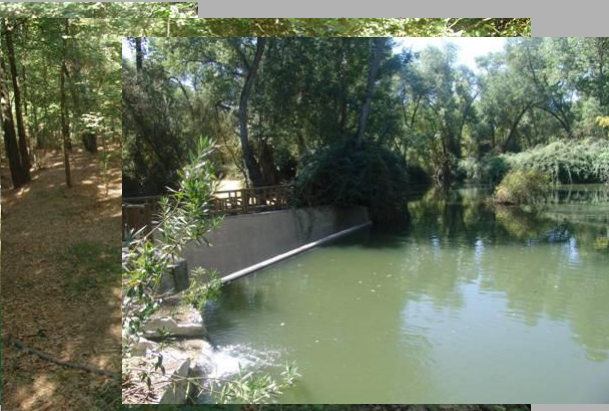
Present conditions:

- Macrophyte invasion in the artificial ponds
- Concrete structures seem out of place in the natural environment

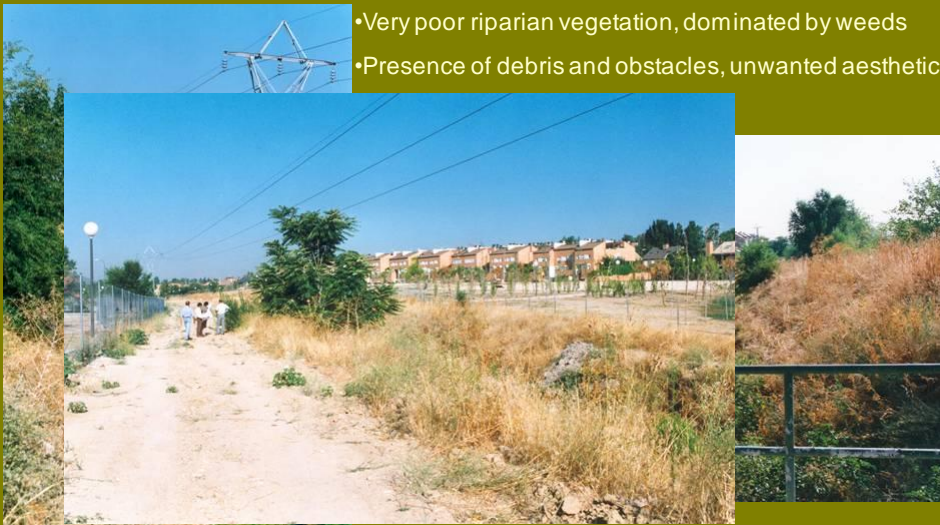
Main problems:

- Small, channelized ditch-type channel, normally dry
- Very poor riparian vegetation, dominated by weeds
- Presence of debris and obstacles, unwanted aesthetic

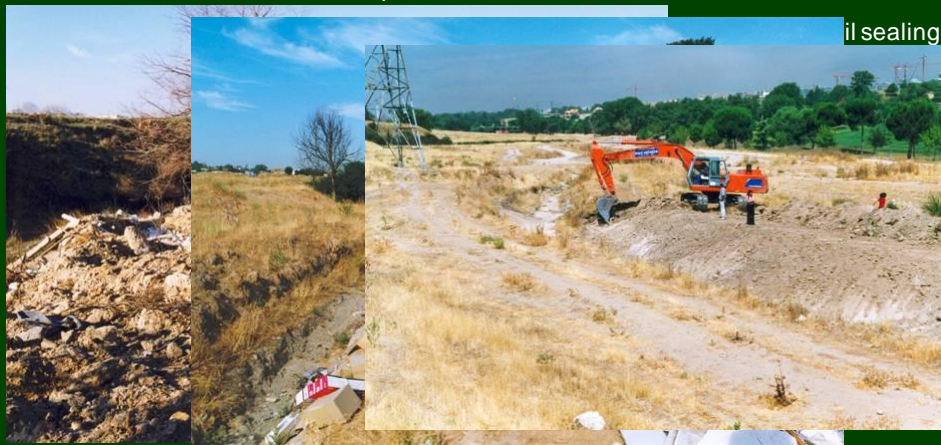
- Main problems:**
- Physical ocupance of the stream by marginal constructions, debris disposals, etc.

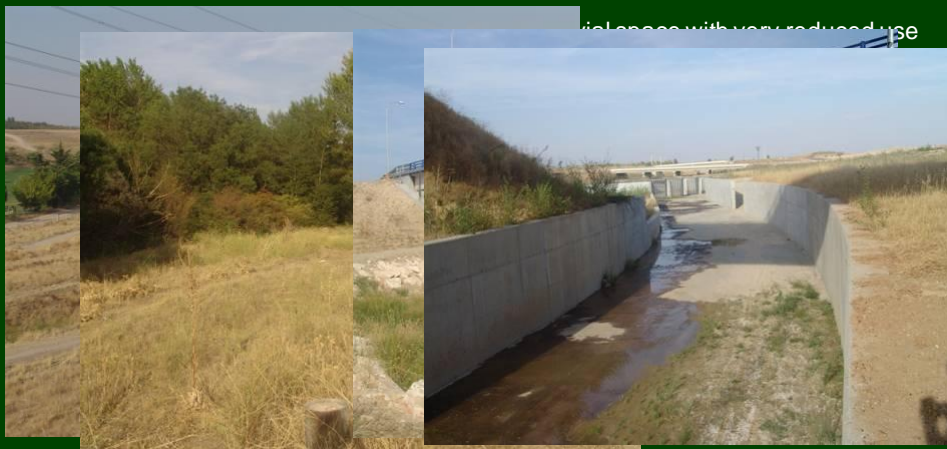
Present conditions: • Dissapearance of riparian plantations
• Riparian space free of debris disposal
