JARAMA RIVER RESTORATION PROJECT (VALDETORRES): Case study

Jarama River: middle reach El Molar (Madrid)

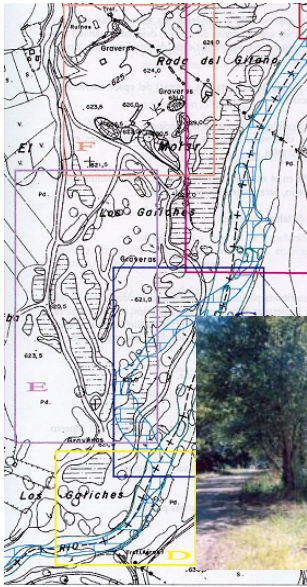
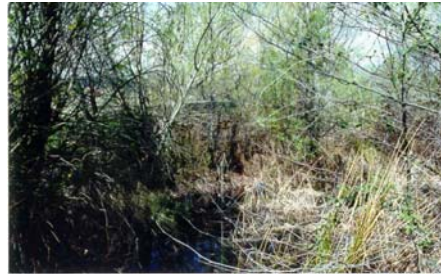
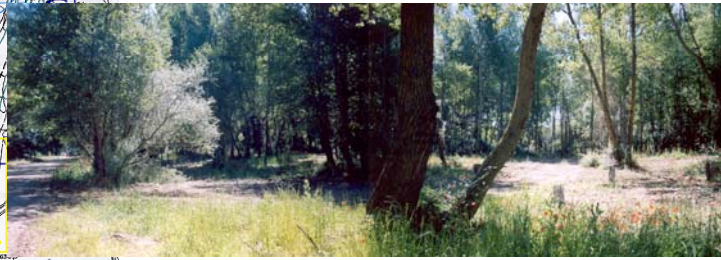
Old levees & dykes

· Presence of many open holes, aisolated by dykes and covered by freatic vegetation

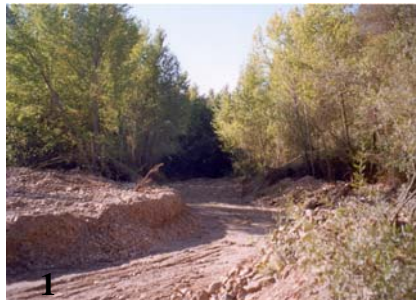
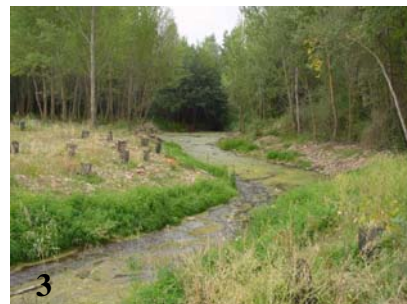
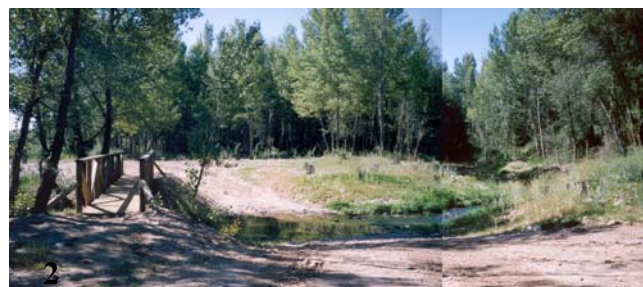
Recovered natural channel, below the lagoon

Costruction of a secondary channel (conectivity and braided)

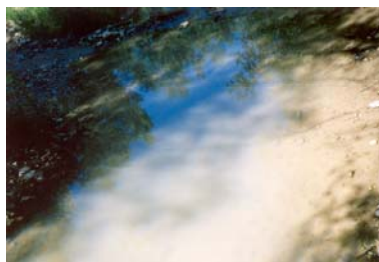
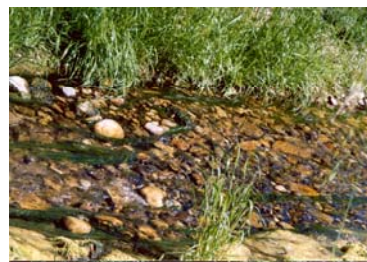
Water quality at entrance and at out-let (2002)

- Eutrophication and water warming below main lagoon
- Fine sediments coming from upstream
- New water outlet
- Flood lamination
- No funds for monitoring results
